A MASTER PLAN *FOR* PATTERSON PARK *IN* BALTIMORE, MARYLAND

CITY OF BALTIMORE DEPARTMENT OF RECREATION AND PARKS  
CAPITAL PROJECTS AND PLANNING DIVISION

JANUARY 1998

*Rhodeside and Harwell, Incorporated*  
*Delon Hampton & Associates, Chartered*  
*A. Morton Thomas and Associates, Inc.*  
*Charles E. Beveridge, Historical Consultant*

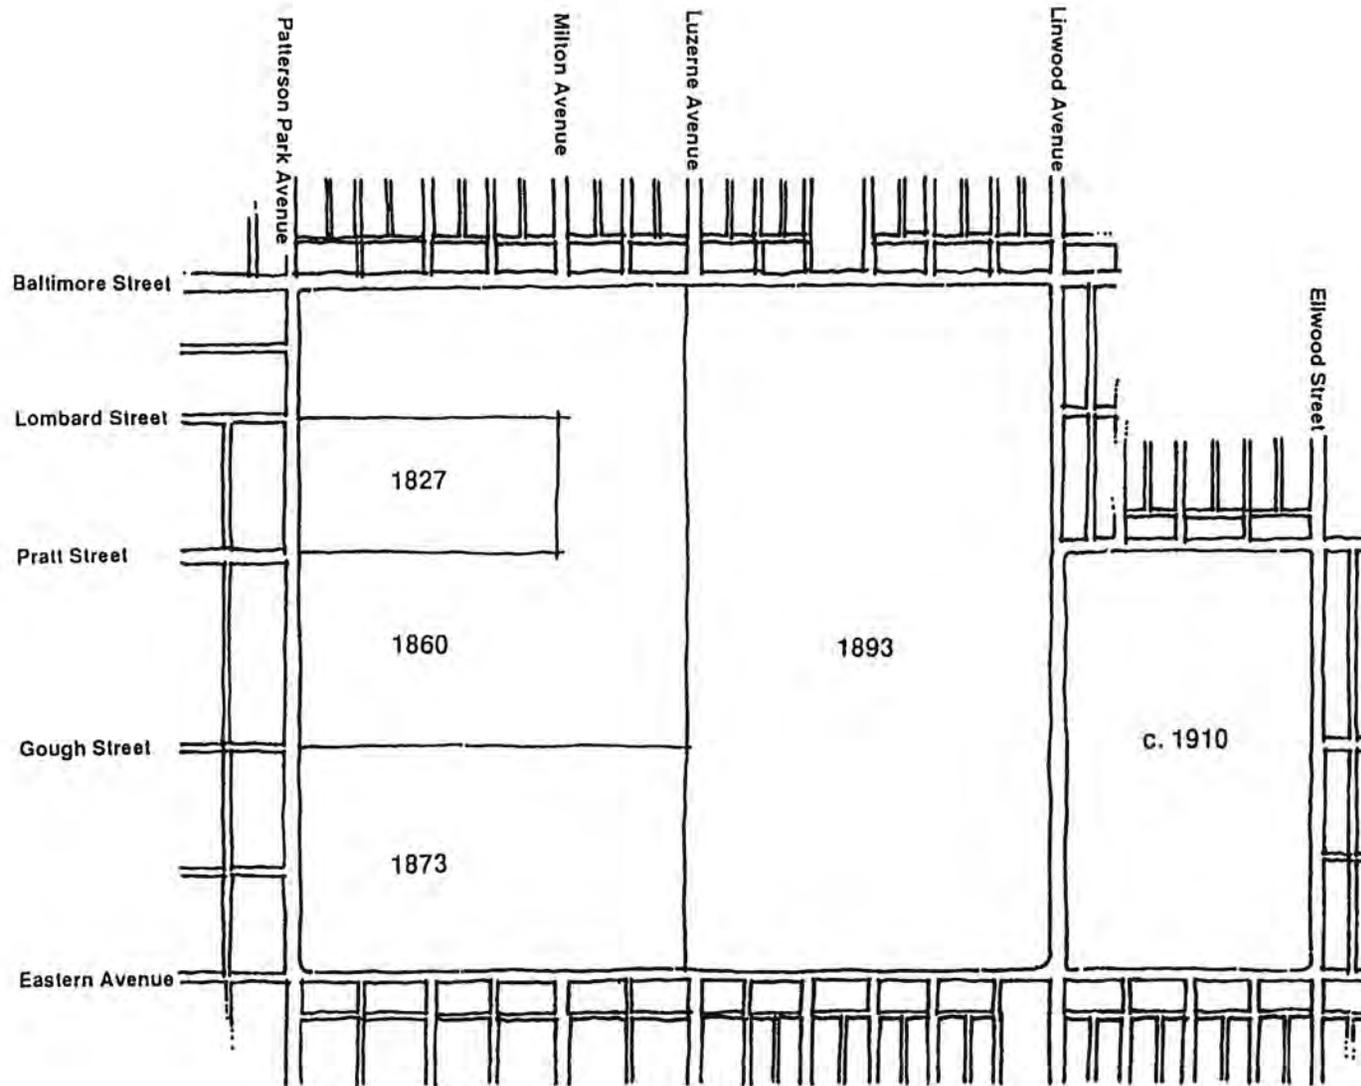
figure 1

LAND ACQUISITION DIAGRAM

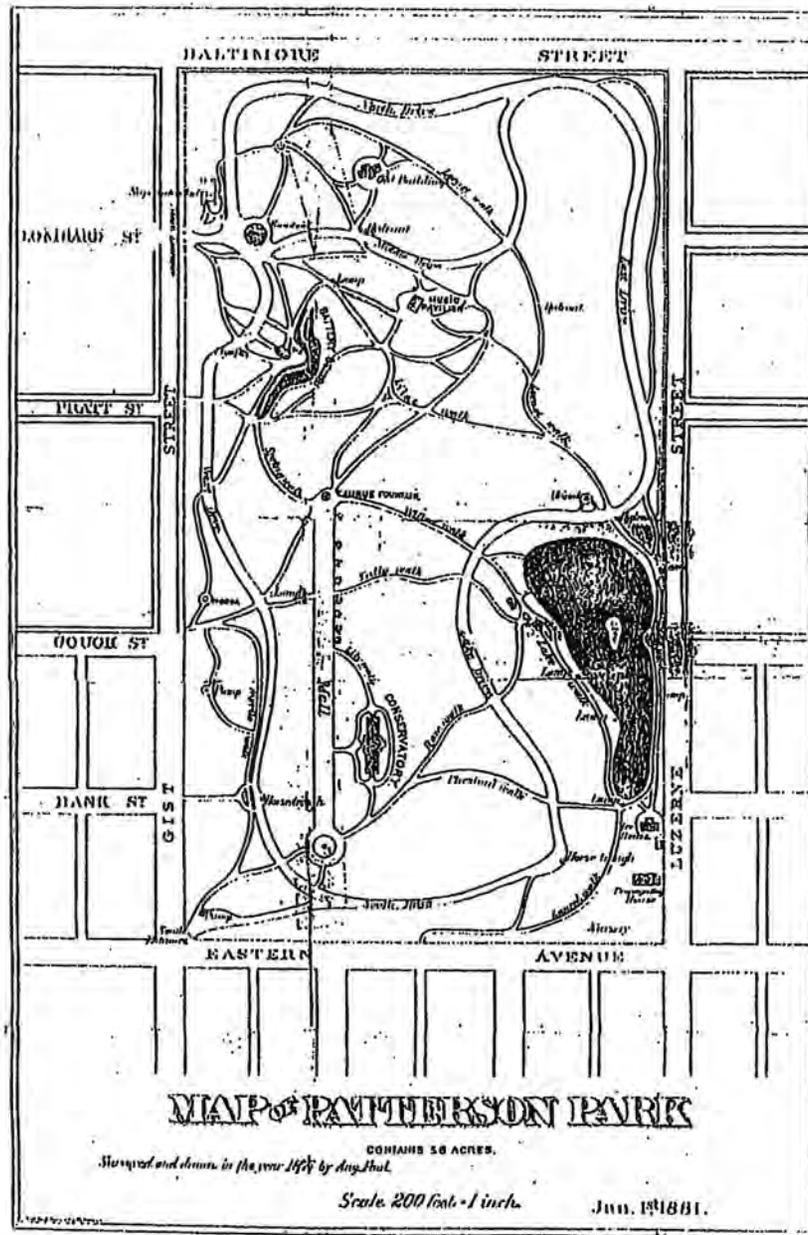
figure 3

1881 MAP OF PATTERSON PARK

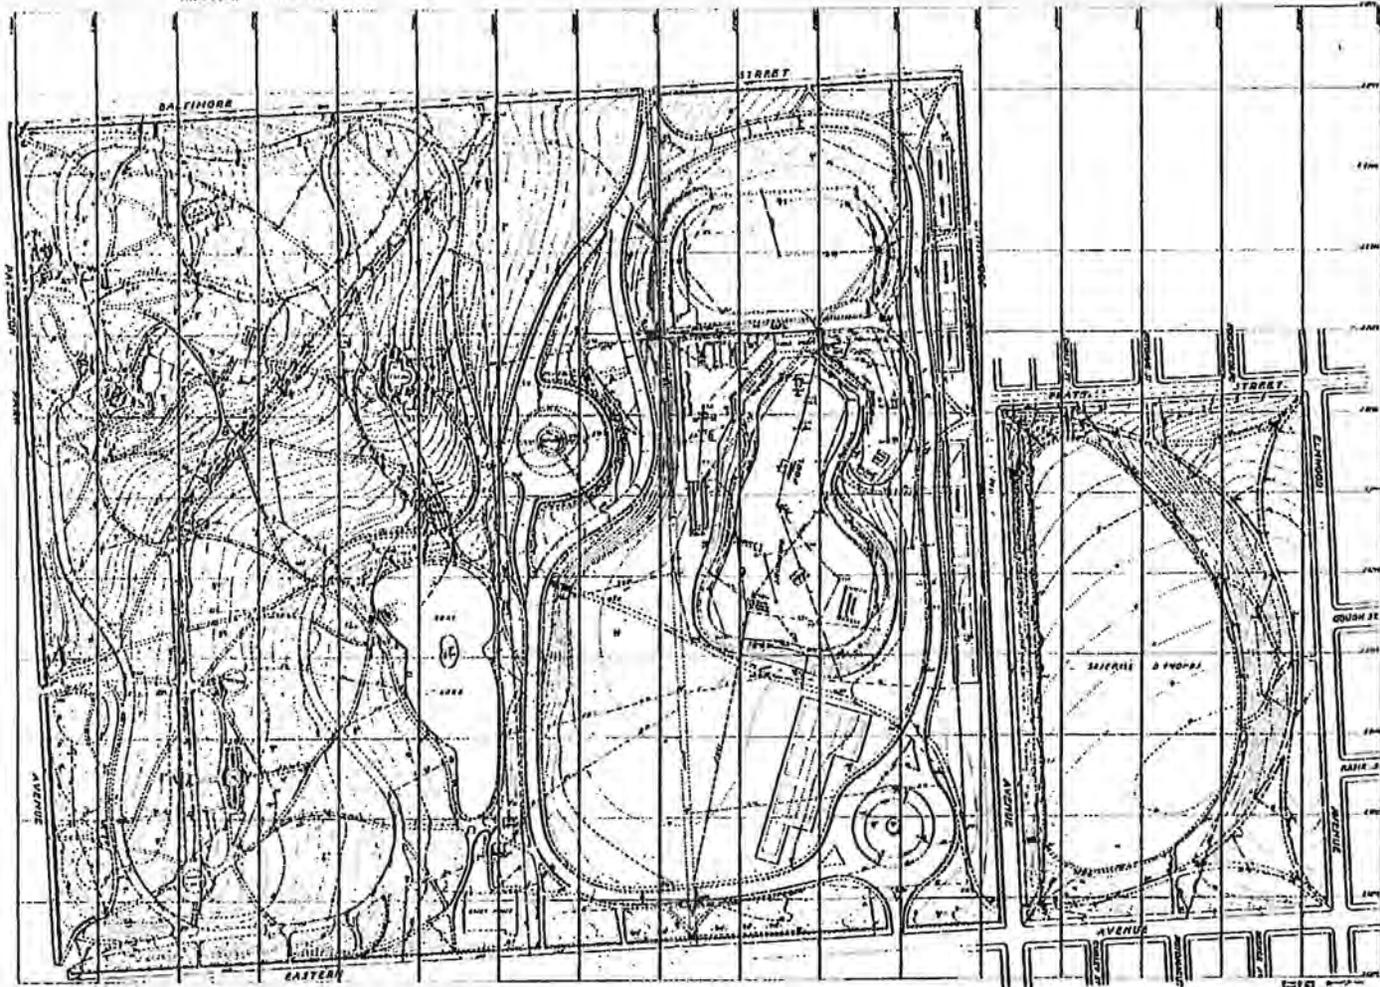
figure 5

1915 PLAN OF PATTERSON PARK PREPARED BY OLNSTED BROTHERS

*Figure 5 illustrates the dawn of the recreation era in Patterson Park. The plan is an inventory of on site conditions in 1915 as drawn by Olmsted Brothers. Only part of the conditions shown reflect landscape architectural design work by Olmsted Brothers.*

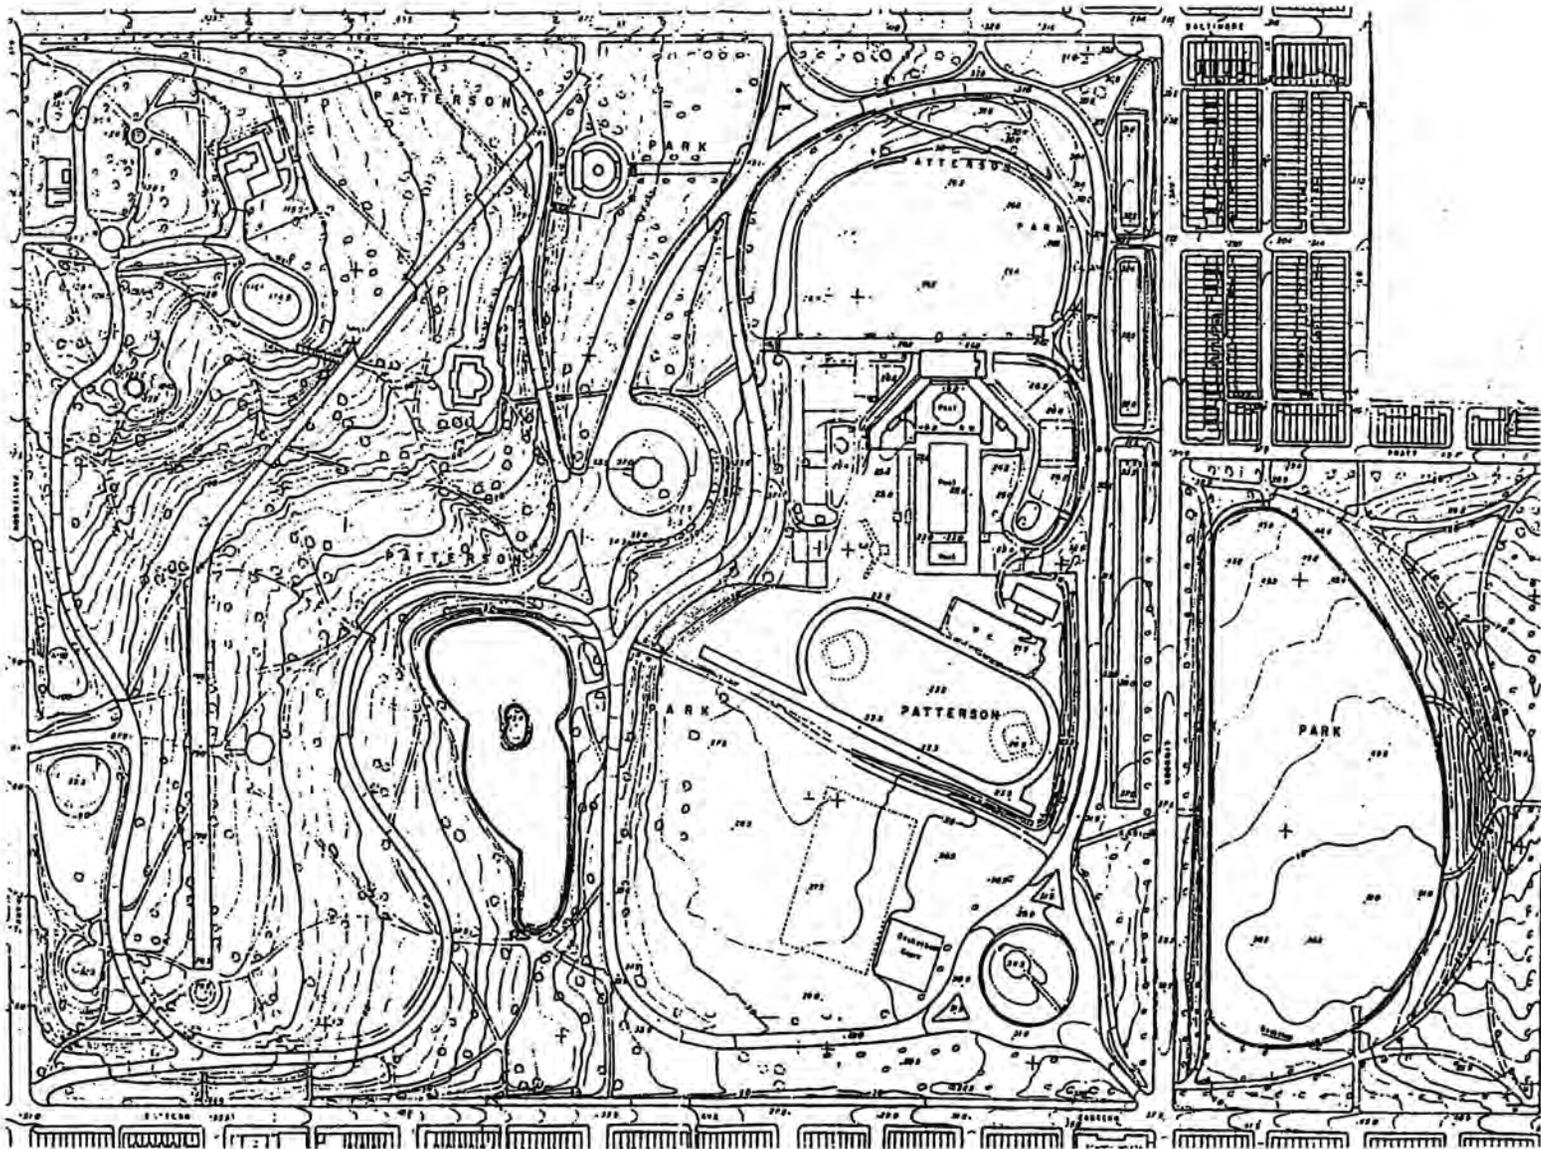
figure 7

CIRCA 1960 MAP OF PATTERSON PARK

Athletic facilities continued to be the major focus of improvements for the remainder of the park's history. Four events had a vital impact on the present day park. First, in 1940, policy was established to eliminate all vehicular traffic from the park. Then, in the 1950s, the lake was drained, filled and replaced with an Olympic-sized pool in the same configuration as the present day pool. Filling the lake made available additional lands for the development of athletic facilities. At this time, Patterson Park was in full use as an urban playground, and the Bureau of Recreation presided over a full program of activities. The park included 15 baseball and softball fields and 17 tennis courts (Figure 7).

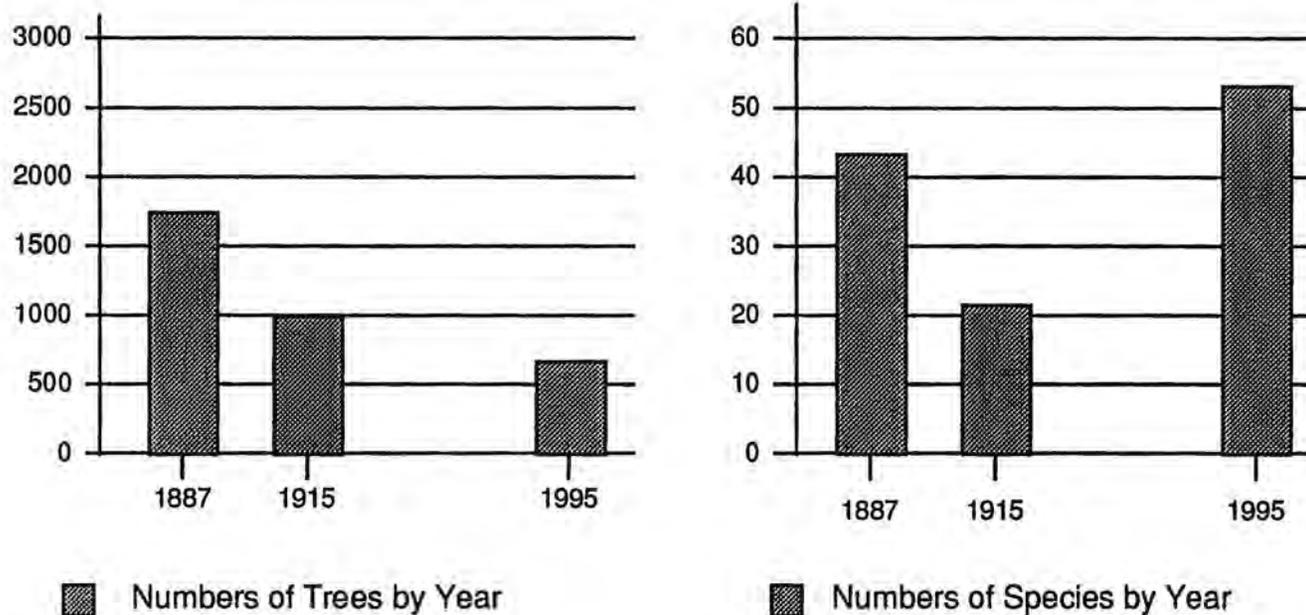
figure 8

THE TREES OF PATTERSON PARK WEST OF LINWOOD AVENUE, 1887-1995

current master plan. Since the park was only six acres in 1835, the major trends were established beginning in 1887 when the park was 144 acres (i.e. west of Linwood Avenue only). Presently, the park west of Linwood Avenue has 808 trees, half the number that were in the park in 1887, and three quarters of the number found there in 1915.

Since 1915, species diversity has increased by nearly three times to 59 species. Lindens are now dominant, representing nearly one out of three trees in the park and Oaks are much more prominent at a density of one out of every six trees. Maples, on the other hand, have declined from a previous dominance of one out of three trees to now only one out of ten. Of the maples, the box elder has disappeared; the silver, Norway, and sugar

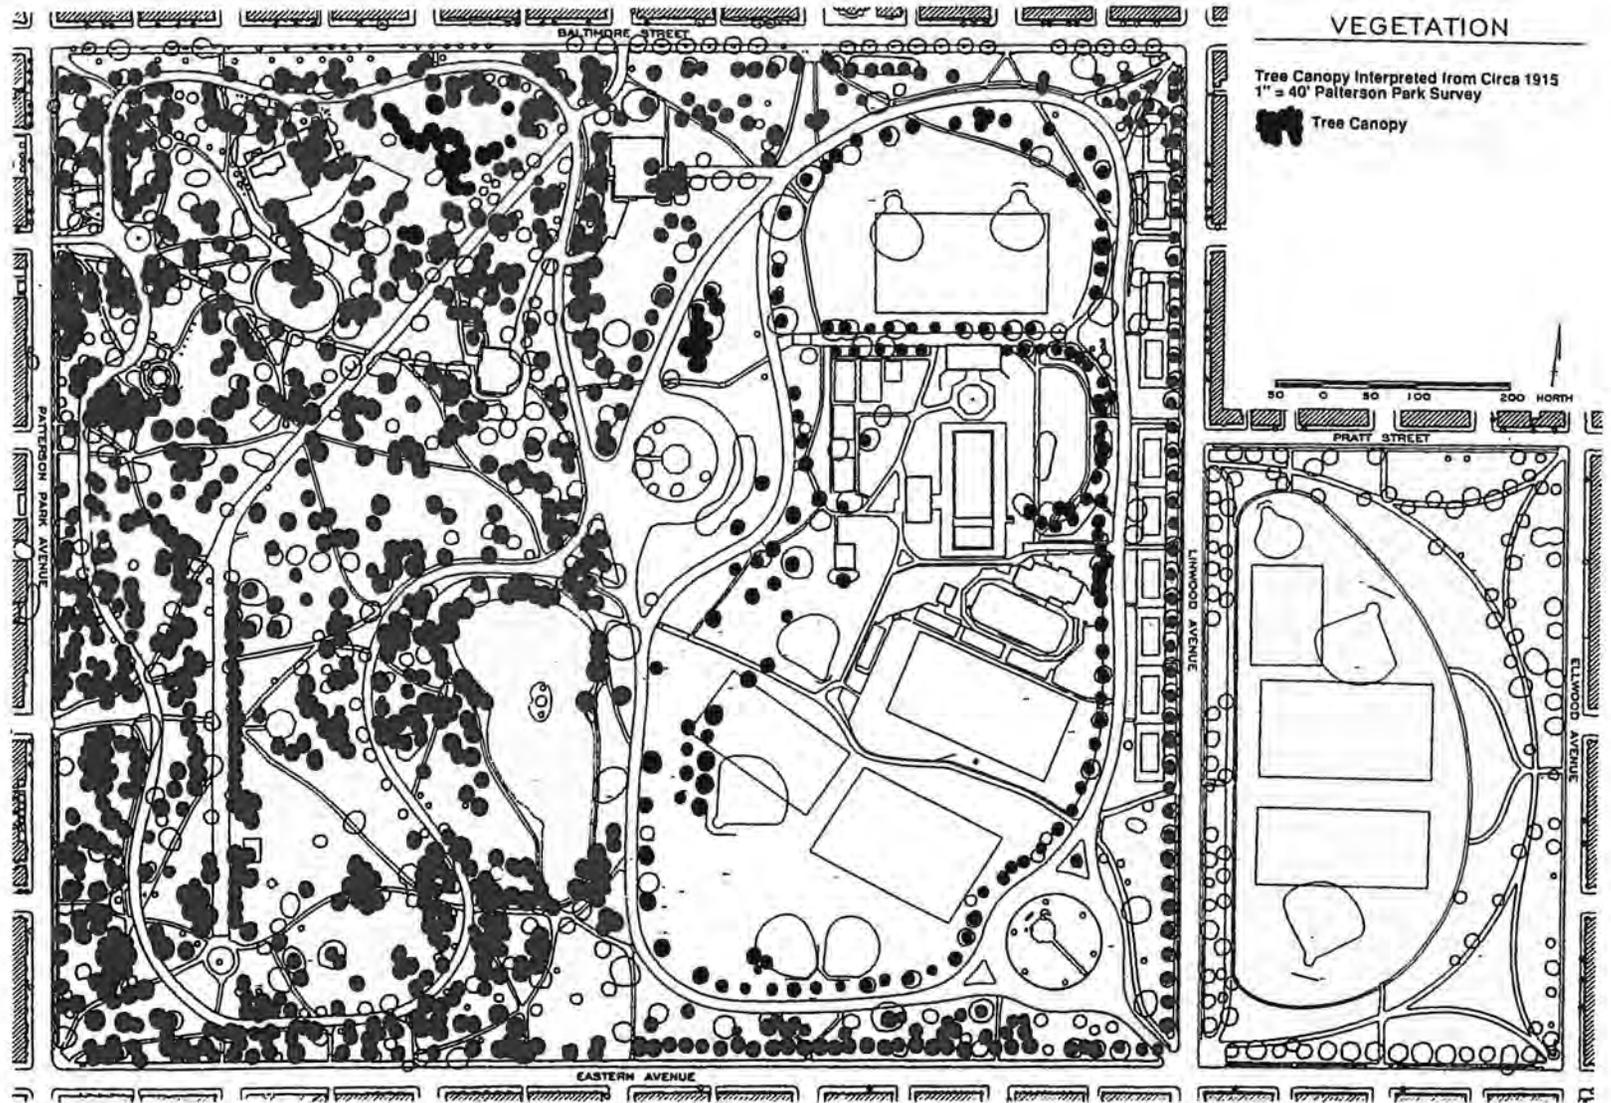
figure 9

CIRCA 1915 TREE CANOPY

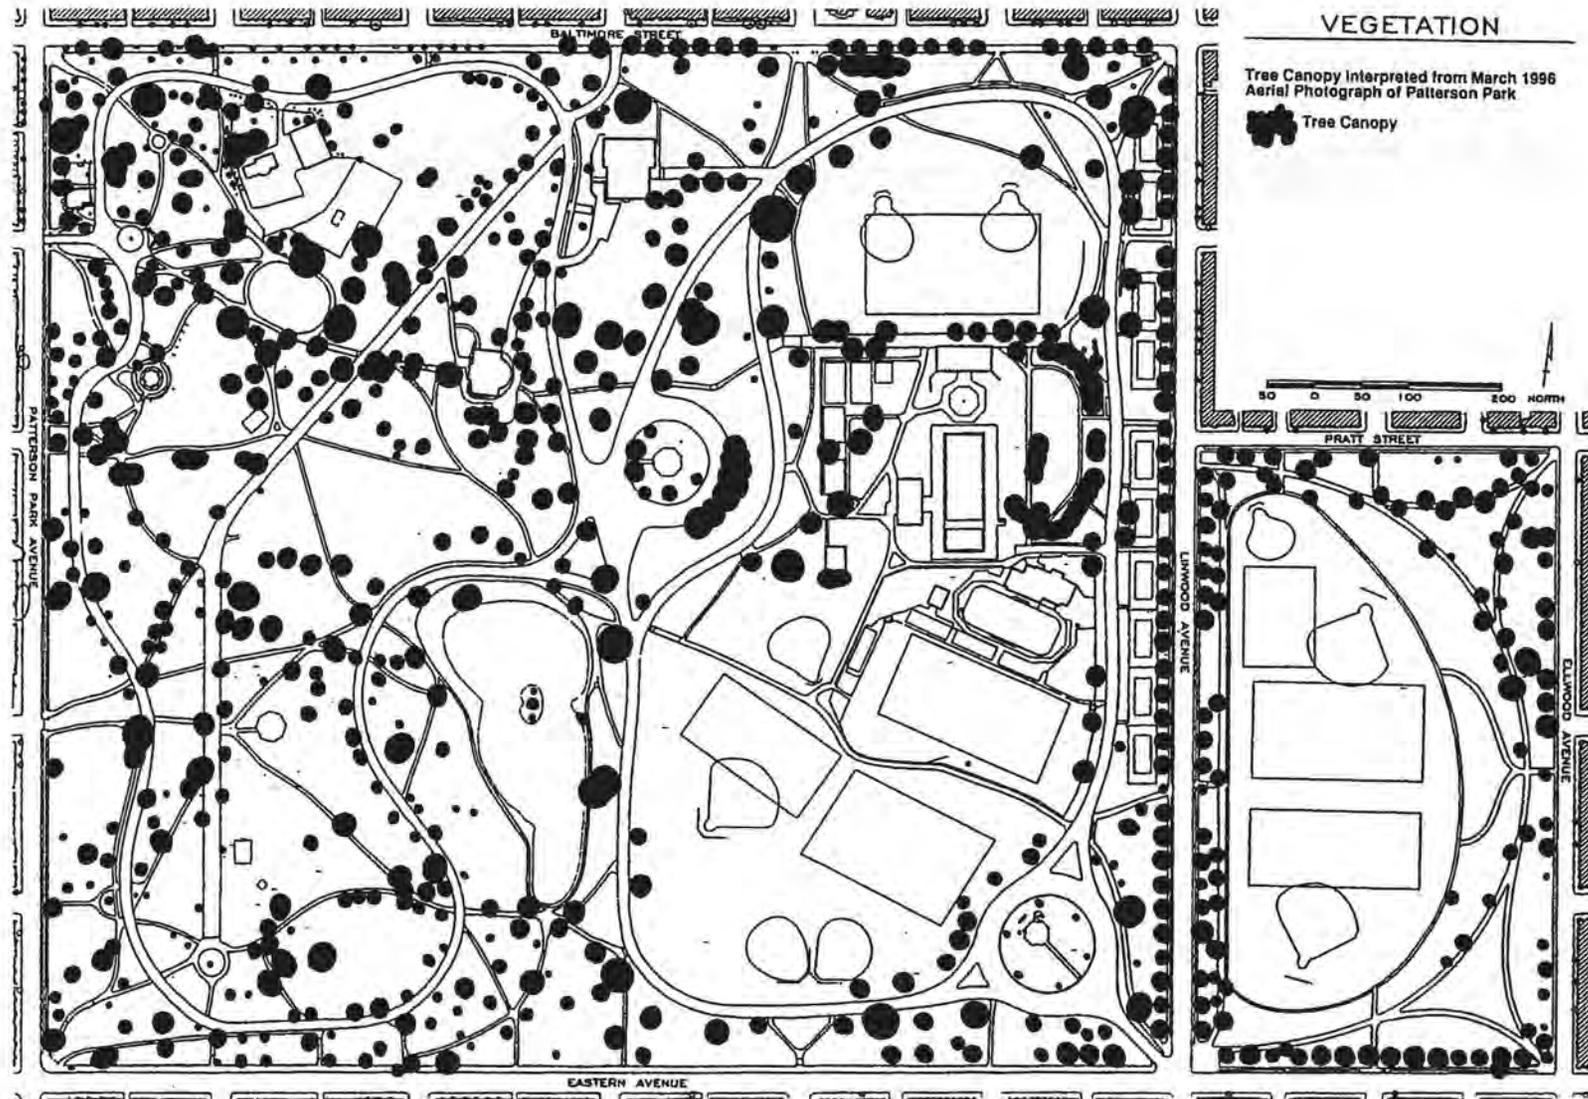
figure 10

1996 TREE CANOPY

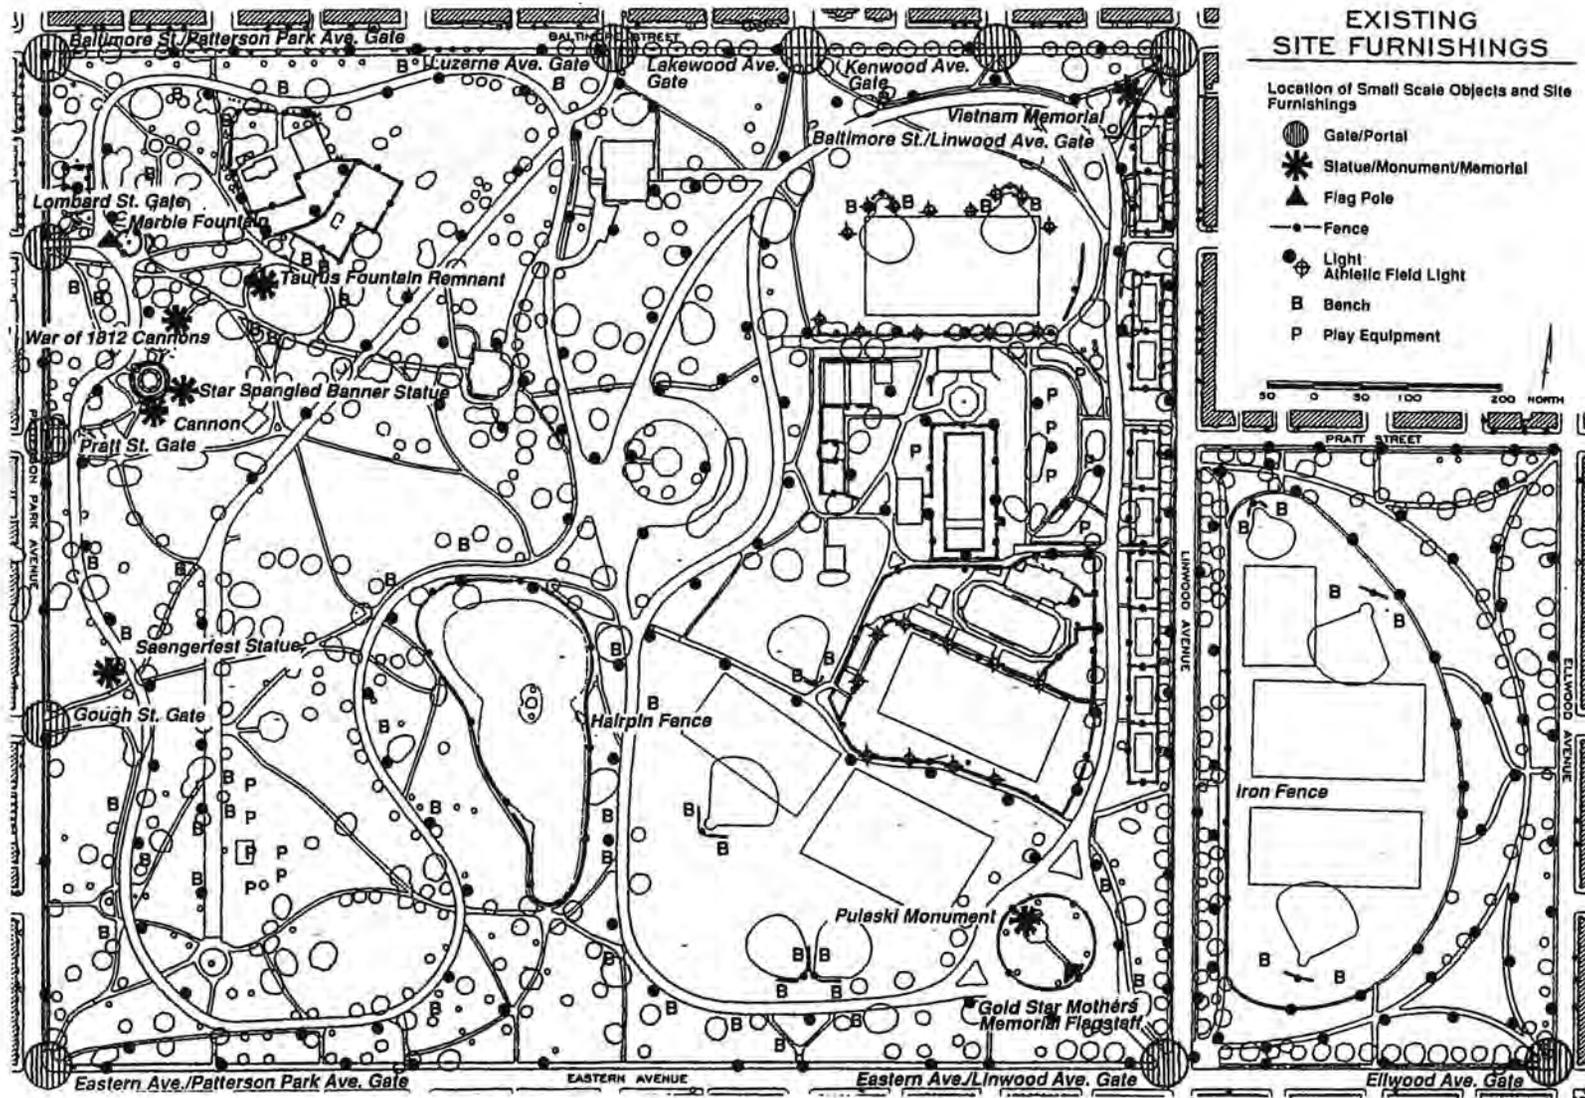
figure 12

EXISTING SITE FURNISHINGS

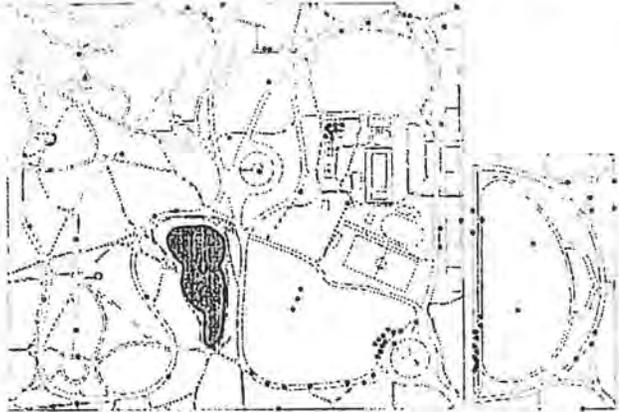
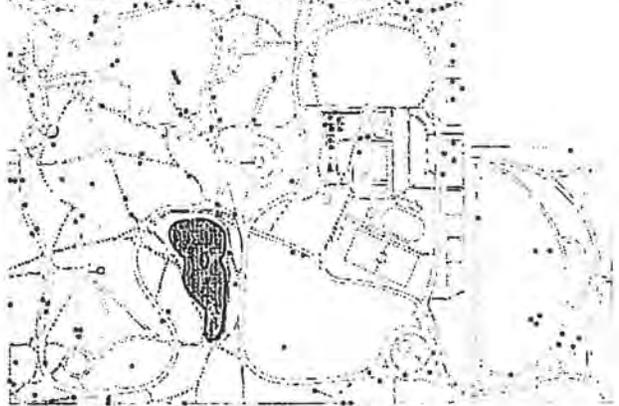
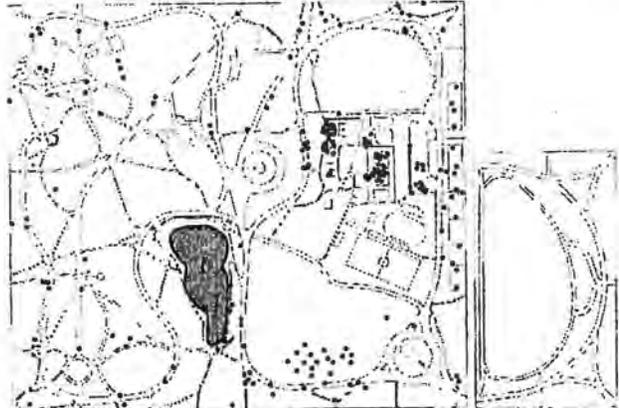
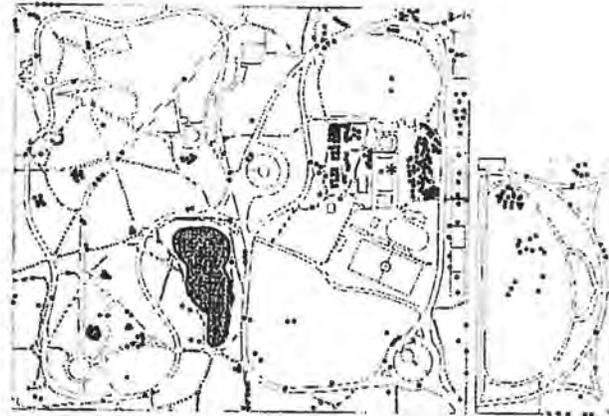
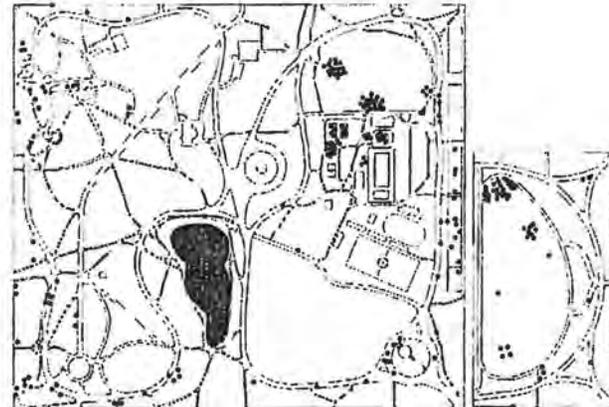
figure 13

PARK USE FOR SUNDAY, JULY 9, 1995

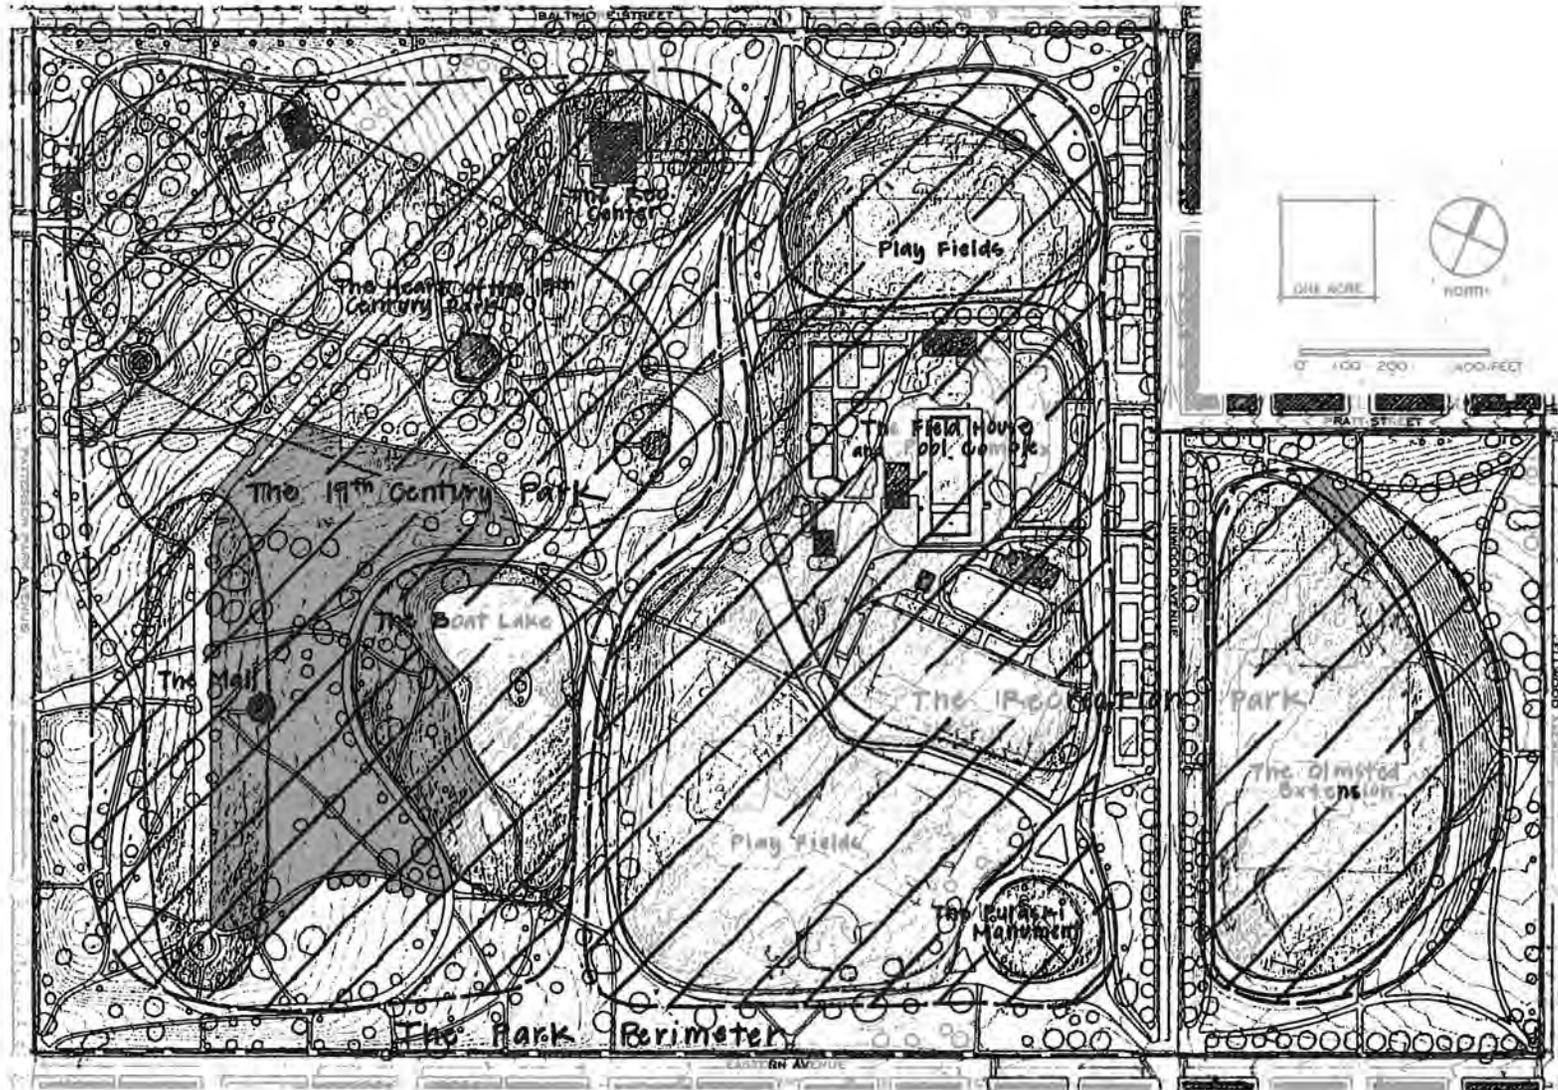
figure 15

PRECINCTS AND ZONES

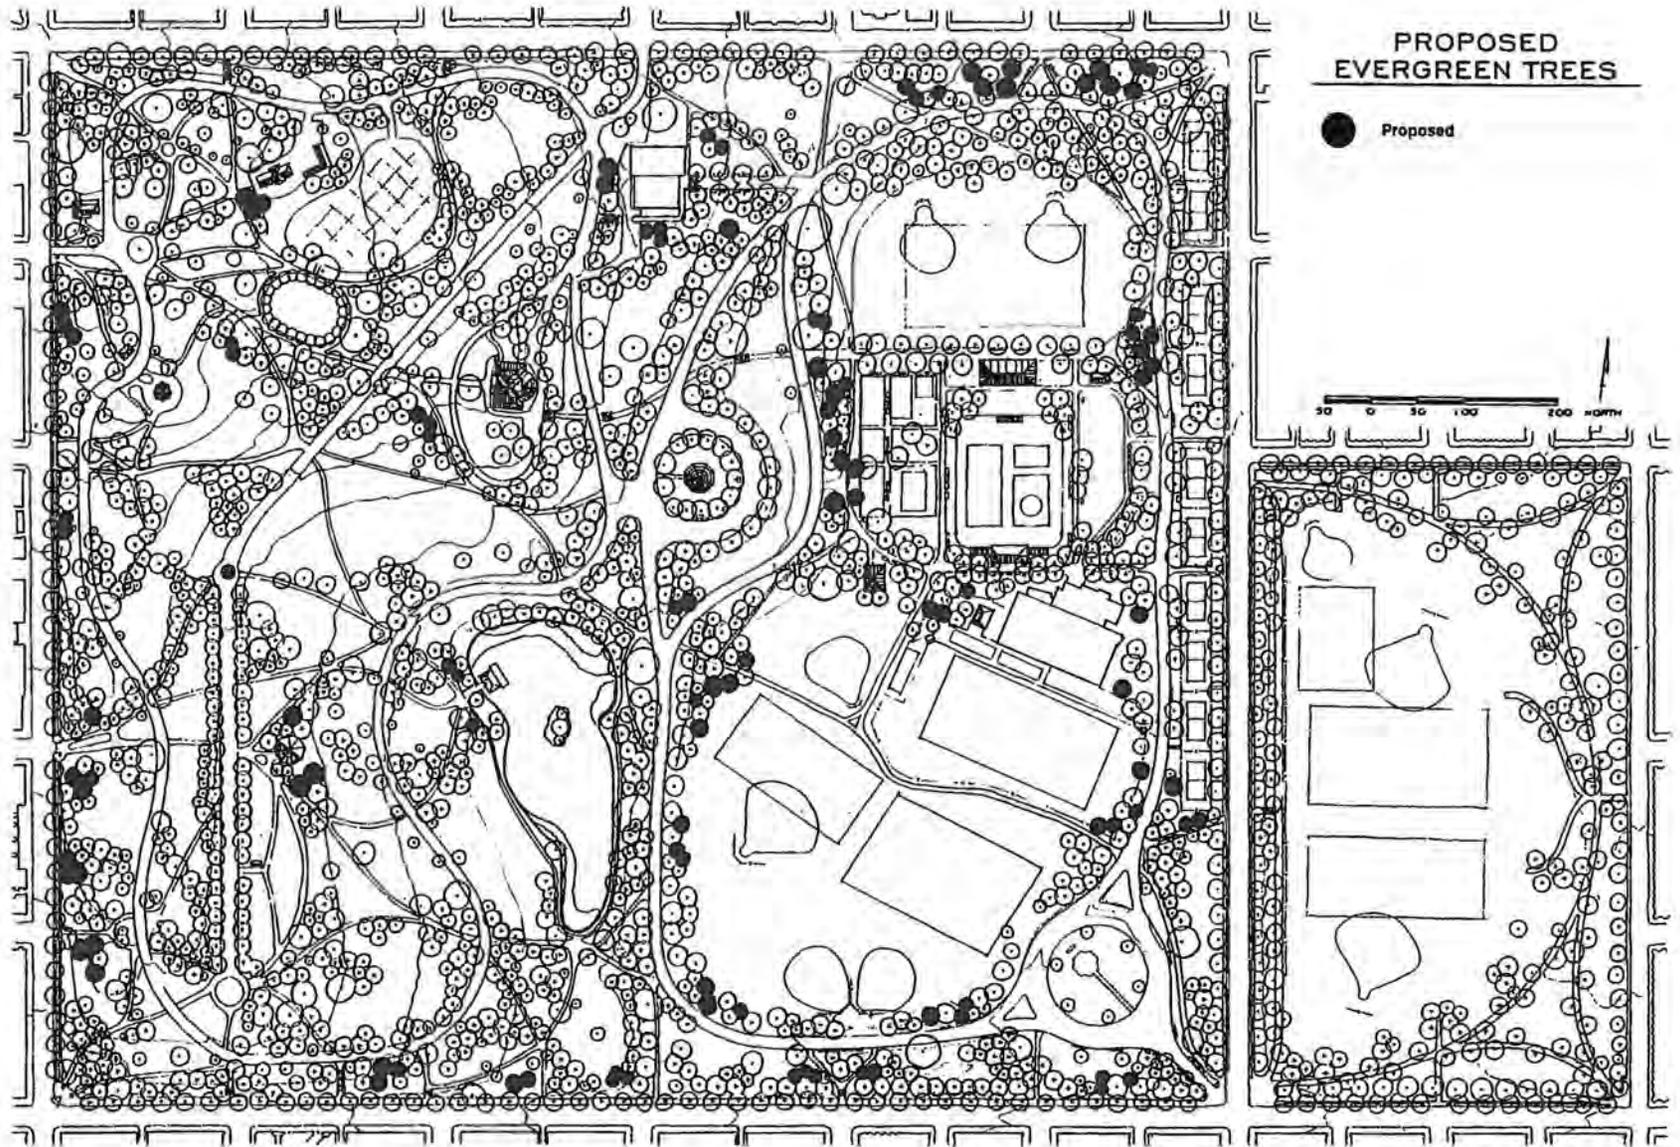
figure 17

PROPOSED EVERGREEN TREES

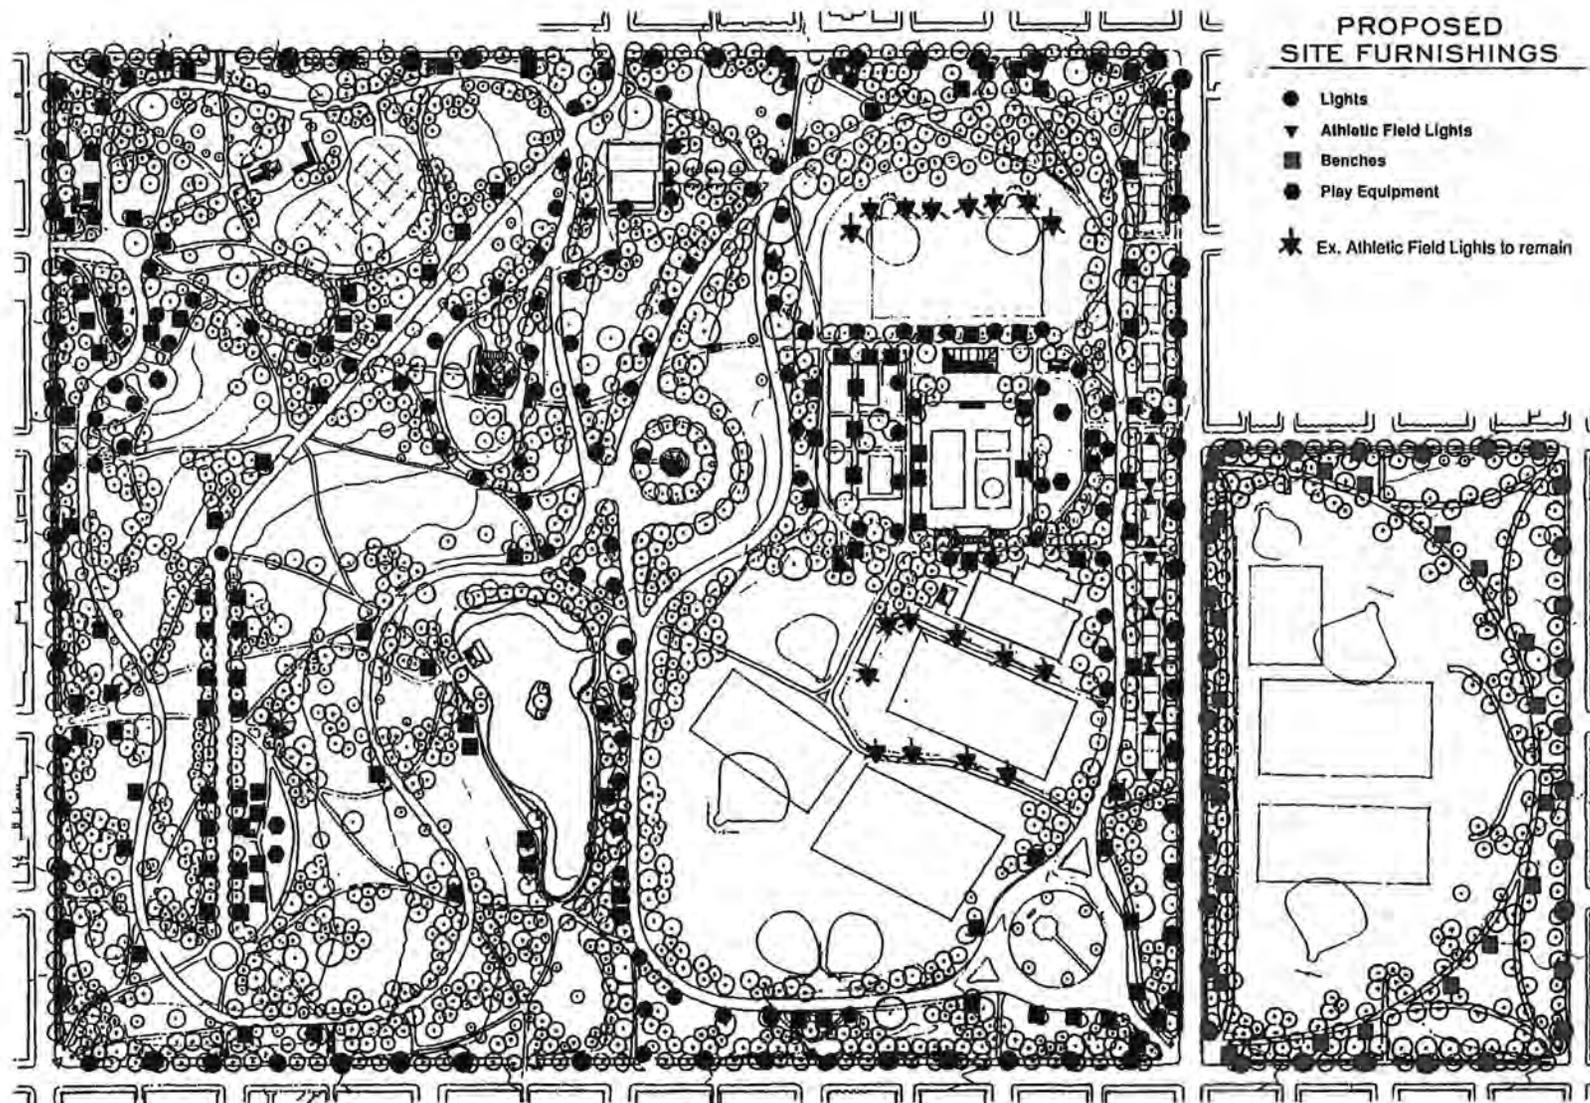
figure 18

LOCATIONS OF SITE FURNISHINGS

- Replace the existing system of low-level lighting along the carriageways and selected paths with a selective, brighter system. New lighting, proposed under the Master Plan, will provide adequate light levels in the park's night use areas and along

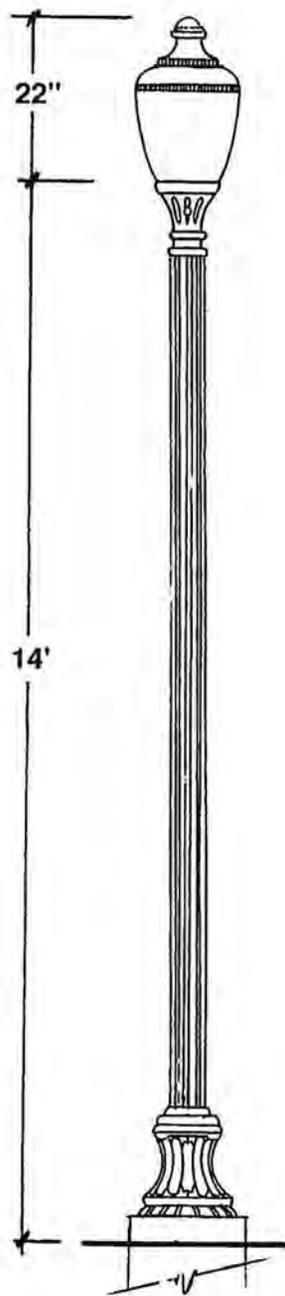
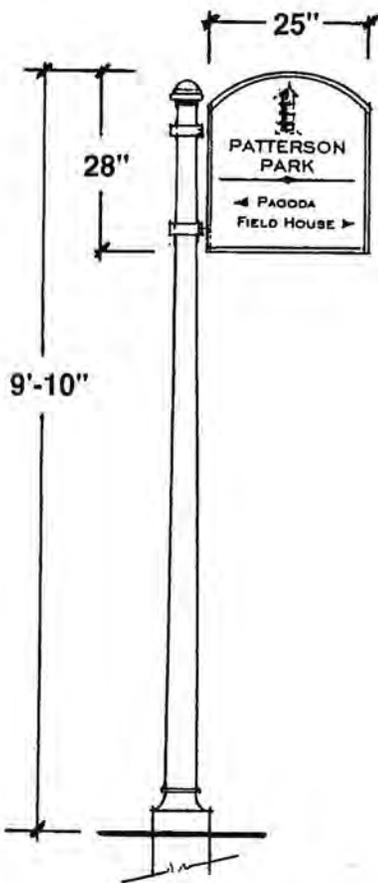
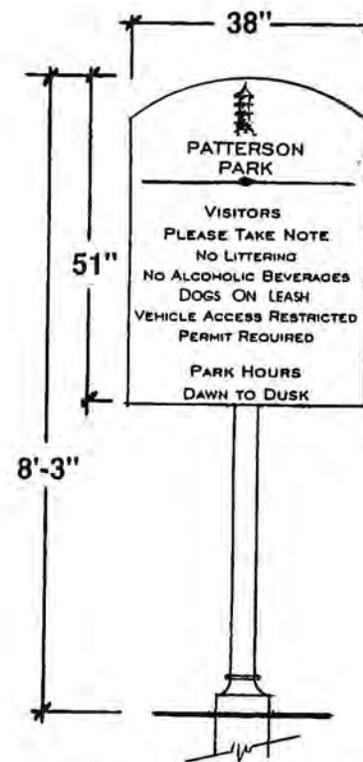
figure 19

TYPICAL SITE FURNISHINGS

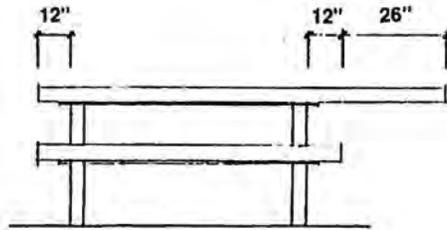
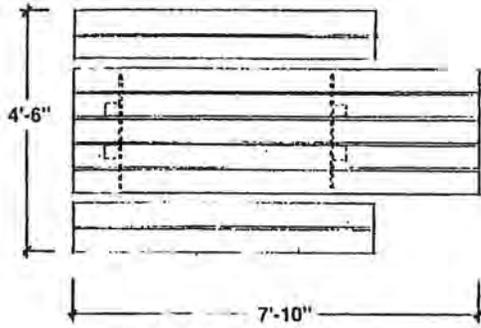
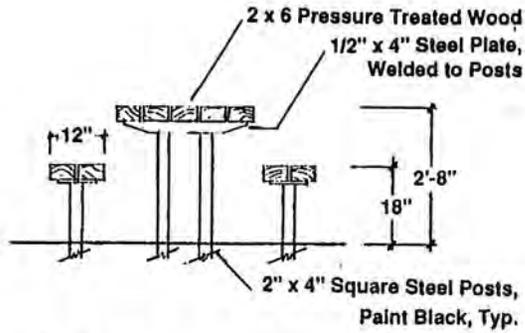
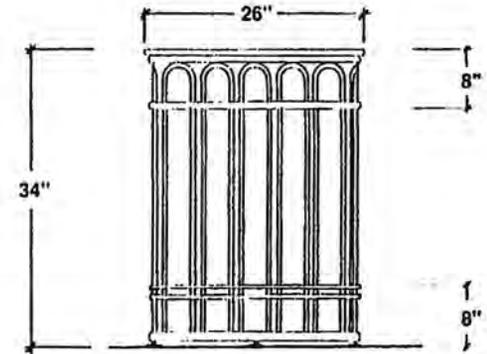
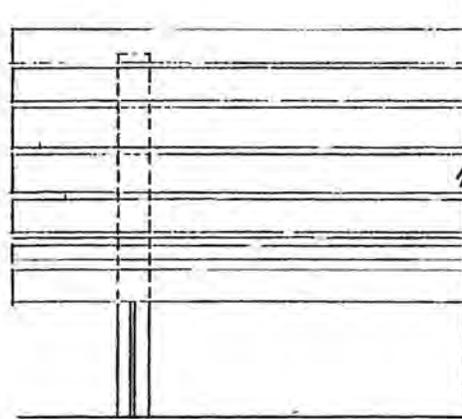
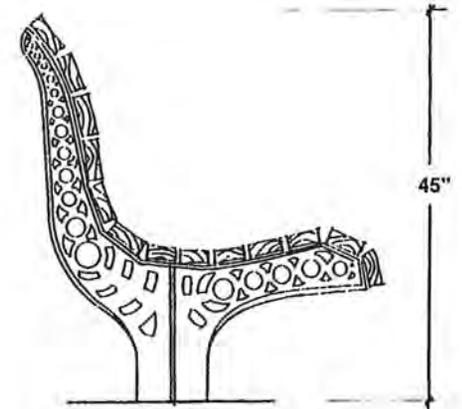
TYPICAL SITE FURNISHINGS

Accessible Picnic Table  
Elevation

Plan

Section

32 Gallon Trash Receptacle  
Elevation

Modified Baltimore Bench  
Section

Baltimore Bench  
Elevation

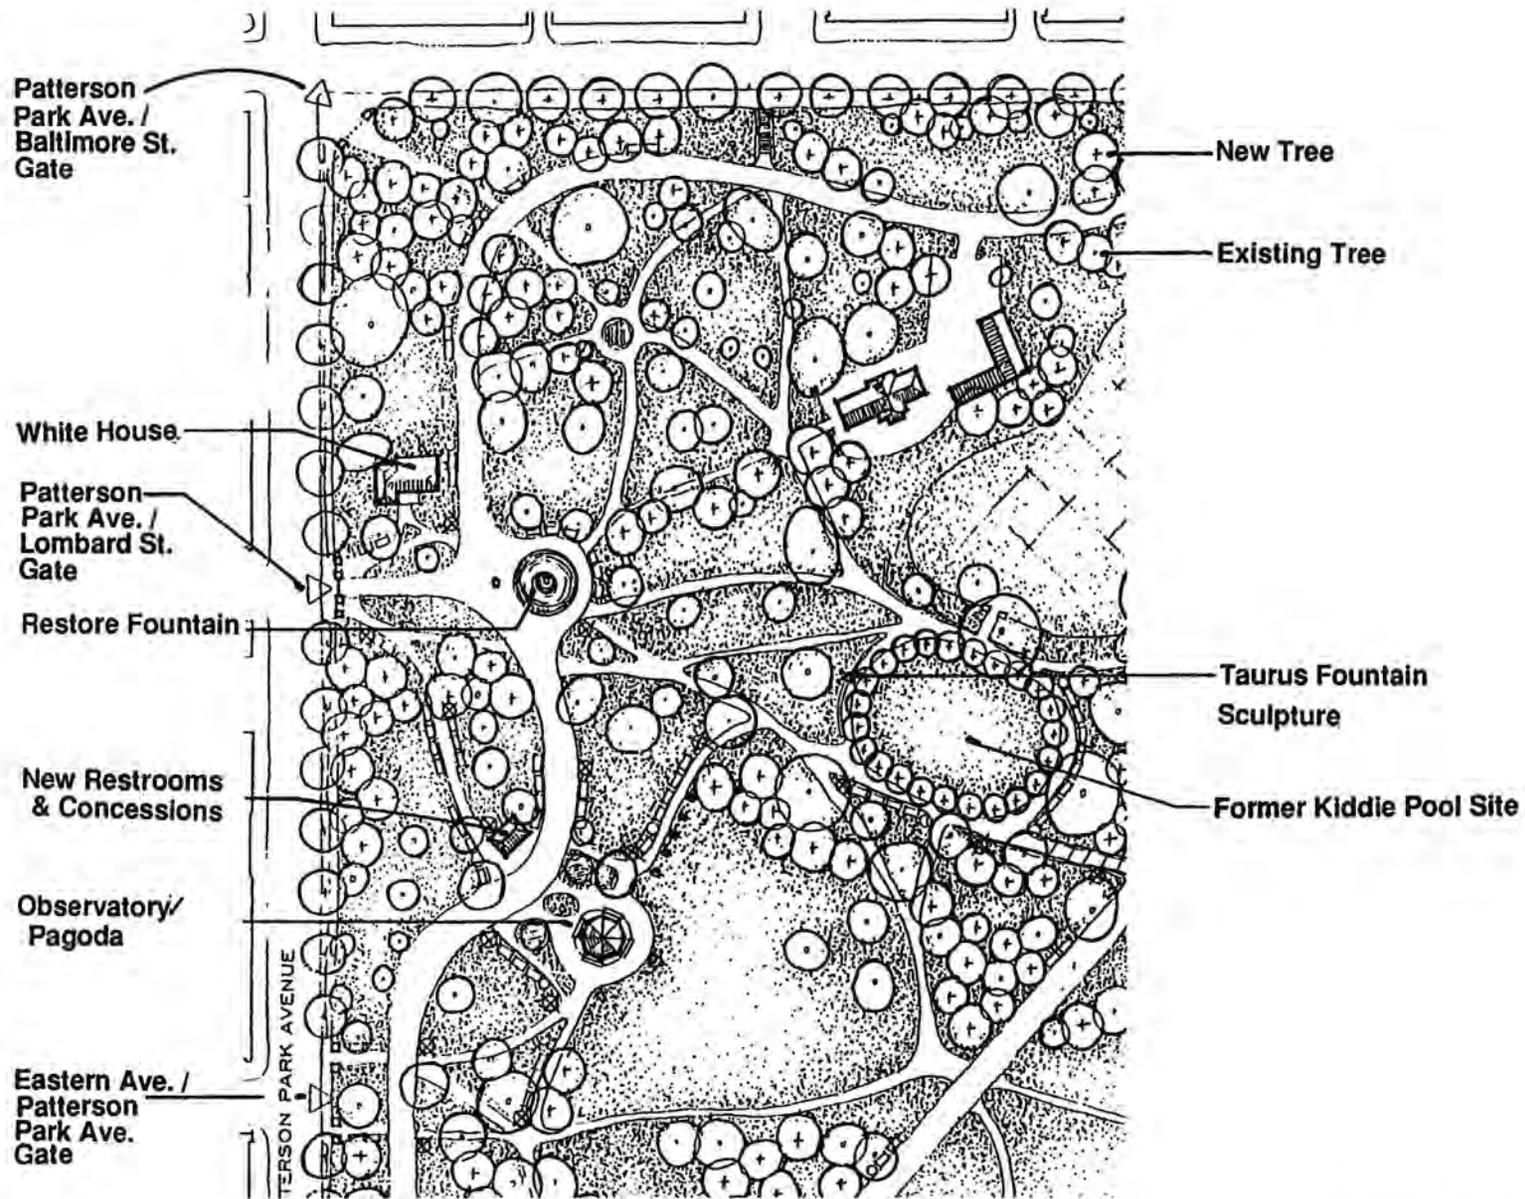
figure 21

THE HEART OF THE PARK
