A MASTER PLAN *FOR* PATTERSON PARK *IN* BALTIMORE, MARYLAND

CITY OF BALTIMORE DEPARTMENT OF RECREATION AND PARKS  
CAPITAL PROJECTS AND PLANNING DIVISION

JANUARY 1998

*Rhodeside and Harwell, Incorporated*  
*Delon Hampton & Associates, Chartered*  
*A. Morton Thomas and Associates, Inc.*  
*Charles E. Beveridge, Historical Consultant*

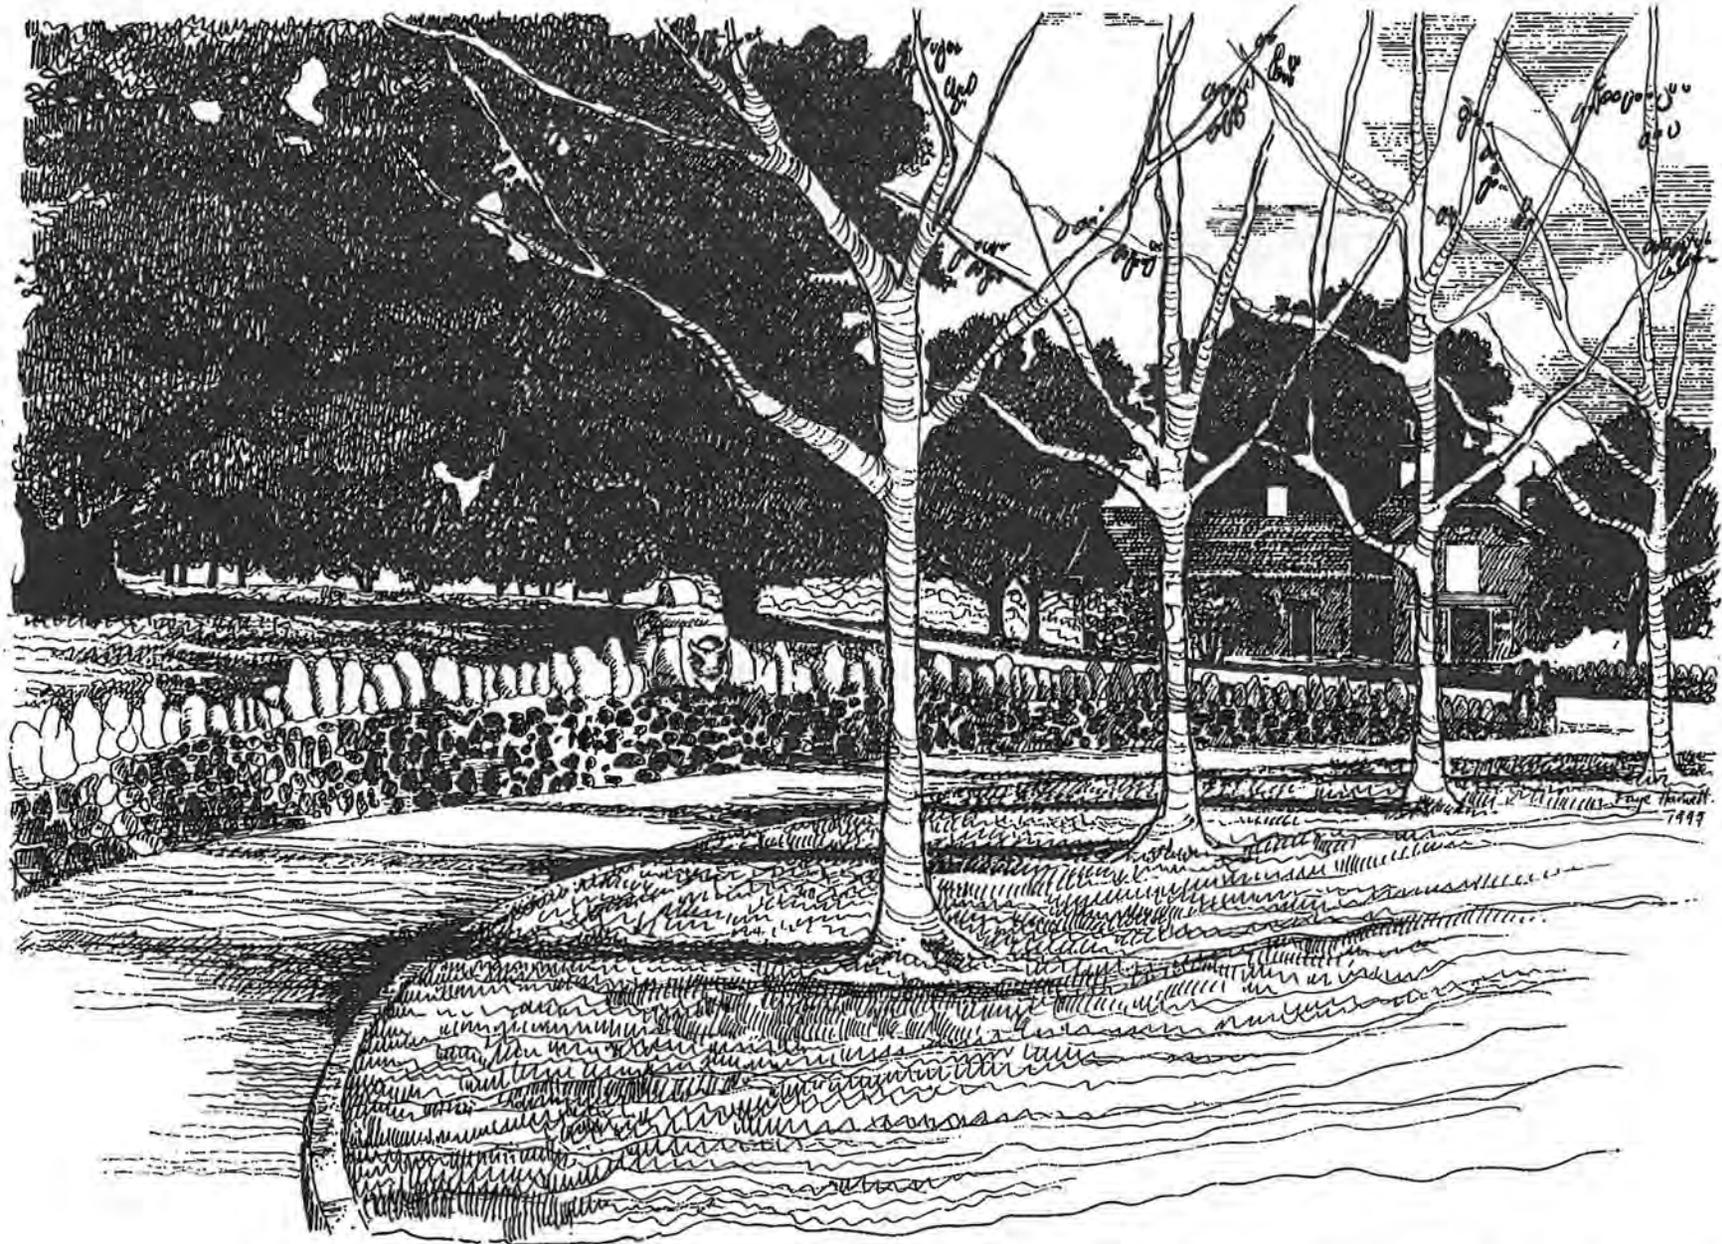
figure 23

VIEW OF REHABILITATION OF STABLES BUILDING AND TAURUS FOUNTAIN SCULPTURE FROM THE FORMER KIDDEE POOL

- Construct a pavilion at the Mall's northern terminus similar in form and scale to the former Taurus Fountain Pavilion. Demolish the existing drinking fountain and pad.
- Establish flower beds along the east side of the Mall and in the circular lawn panel at the Mall's southern terminus.
- Remove existing play equipment at the Conservatory site and construct a new, expanded, custom-designed children's playground on the east side of the Mall.
- Construct a small structure for restrooms on the east side of the Mall on a path connecting the Mall to the Playground.
- Develop a new picnic area on the grounds between the Mall and the carriageway.

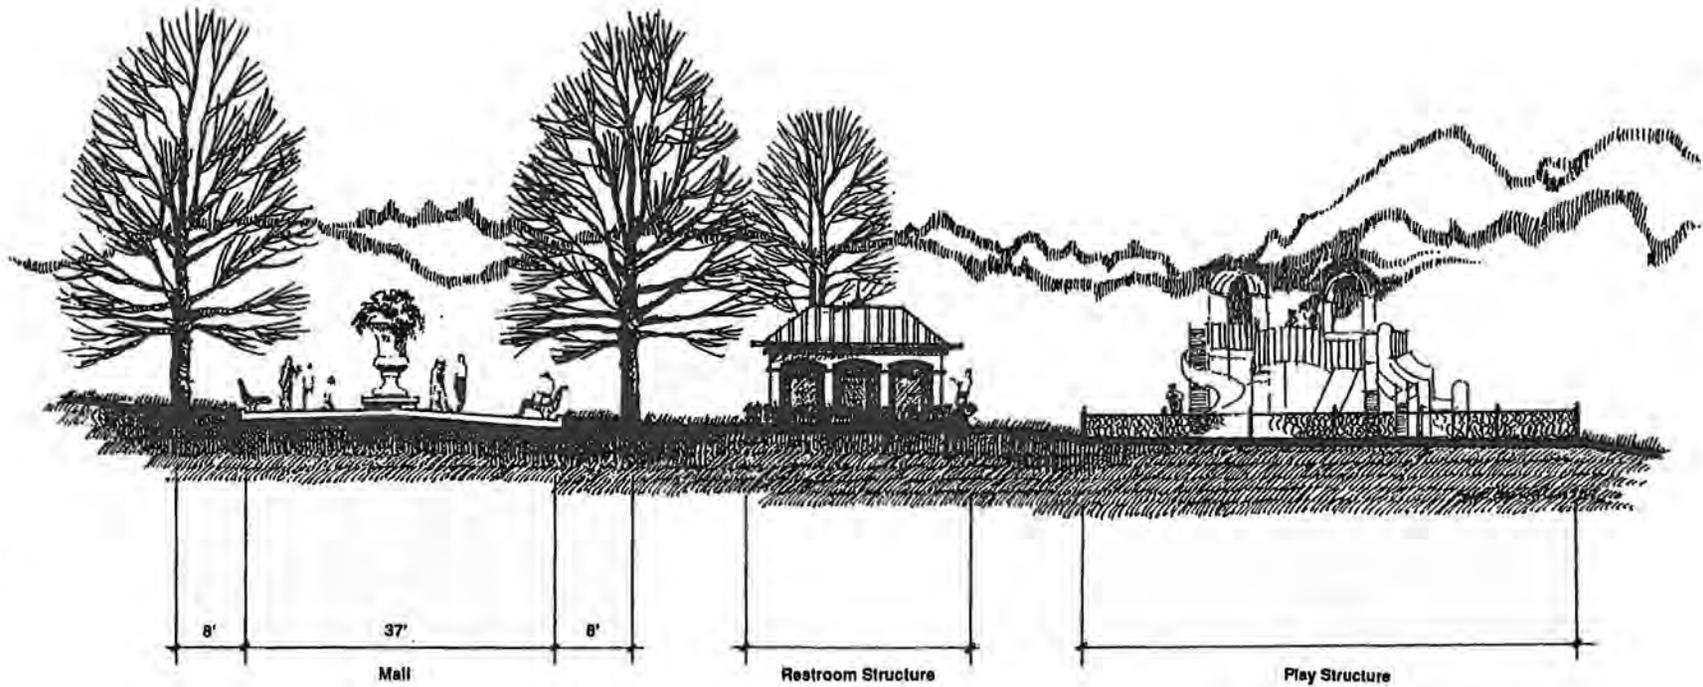
figure 25

SECTION THROUGH RESTORED MALL, LOOKING NORTH

features. The rehabilitation program includes conserving and resetting existing asphalt paver blocks; installing new asphalt pavers to match existing pavers in deteriorated areas; reconstructing the vases and planting them with floral displays; installing new "Baltimore Benches" and trash receptacles; and planting maple trees along the edges. Careful attention should be given to preserving existing trees along the Mall.

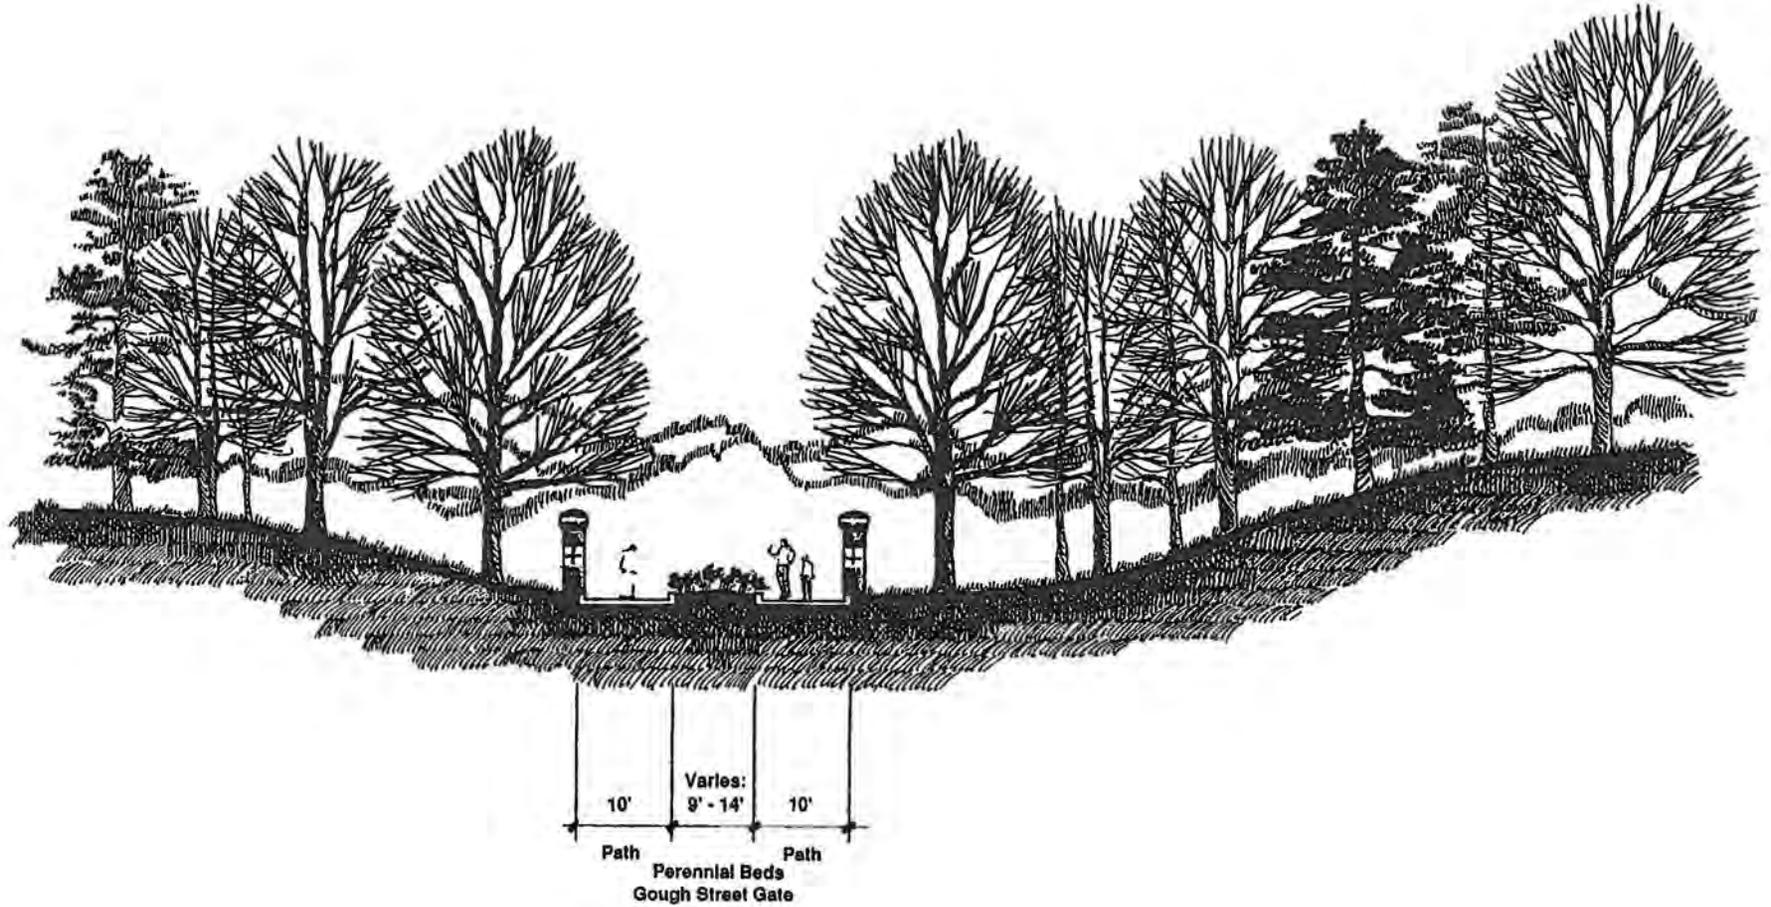
figure 26

SECTION THROUGH GOUGH STREET GATE, LOOKING EAST

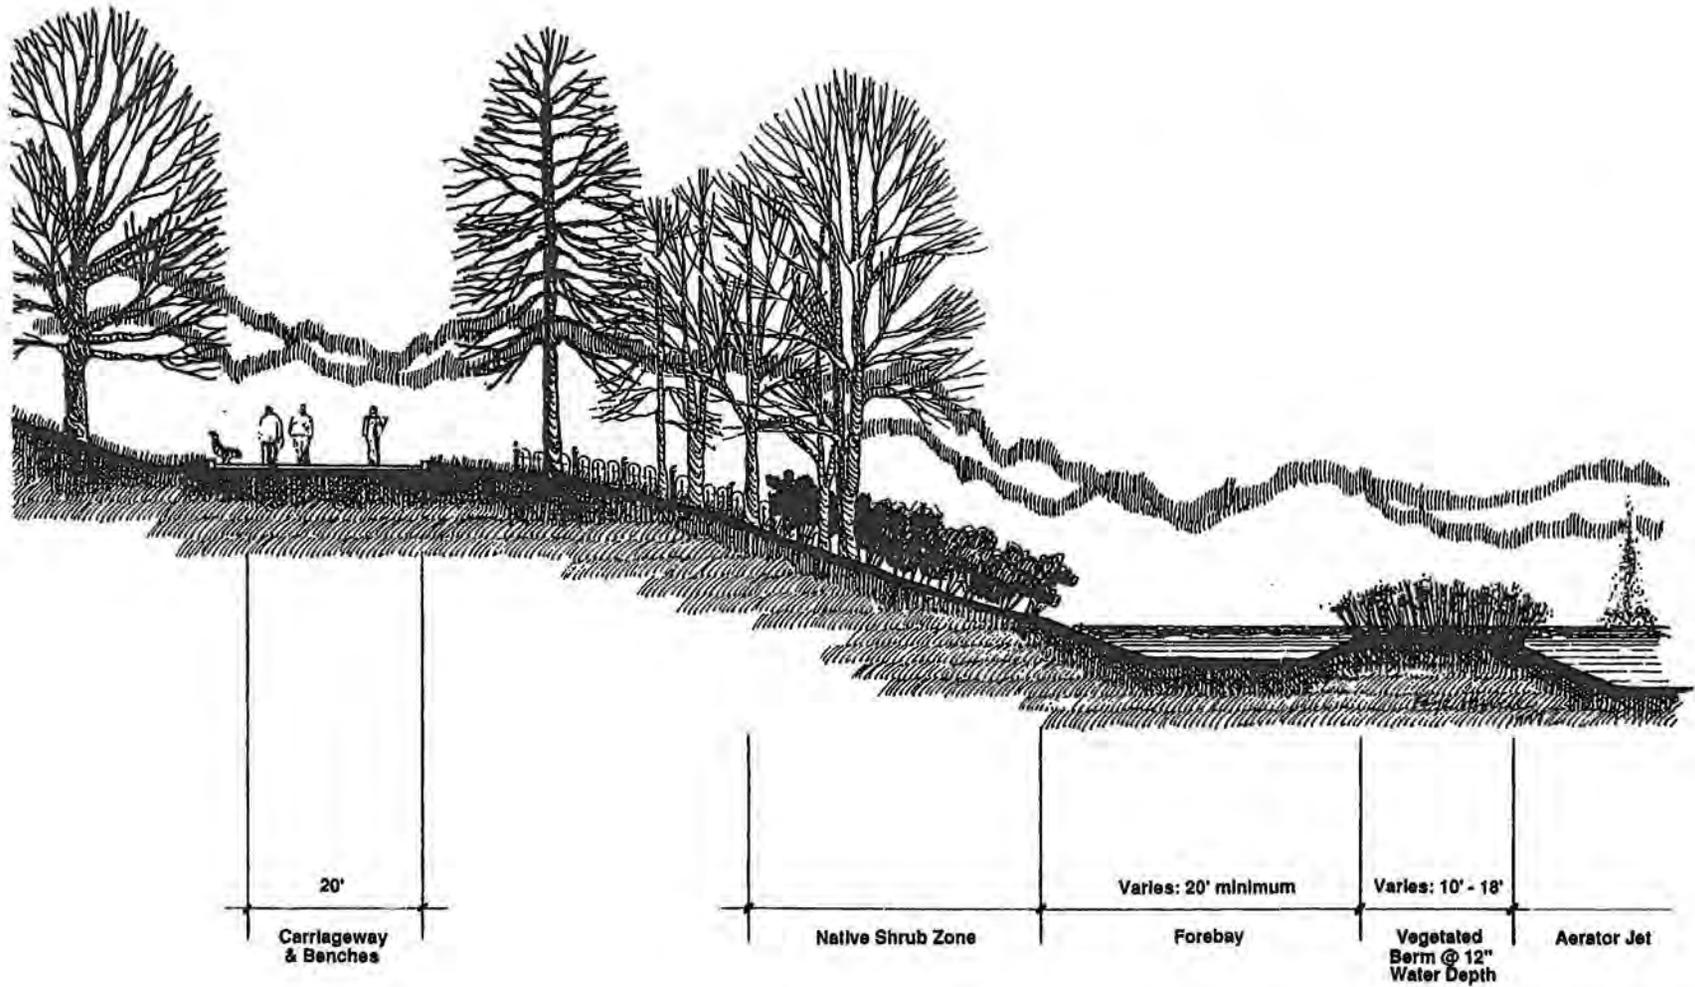
figure 31

SECTION THROUGH NORTH END C/ RESTORED BOAT LAKE, LOOKING EAST

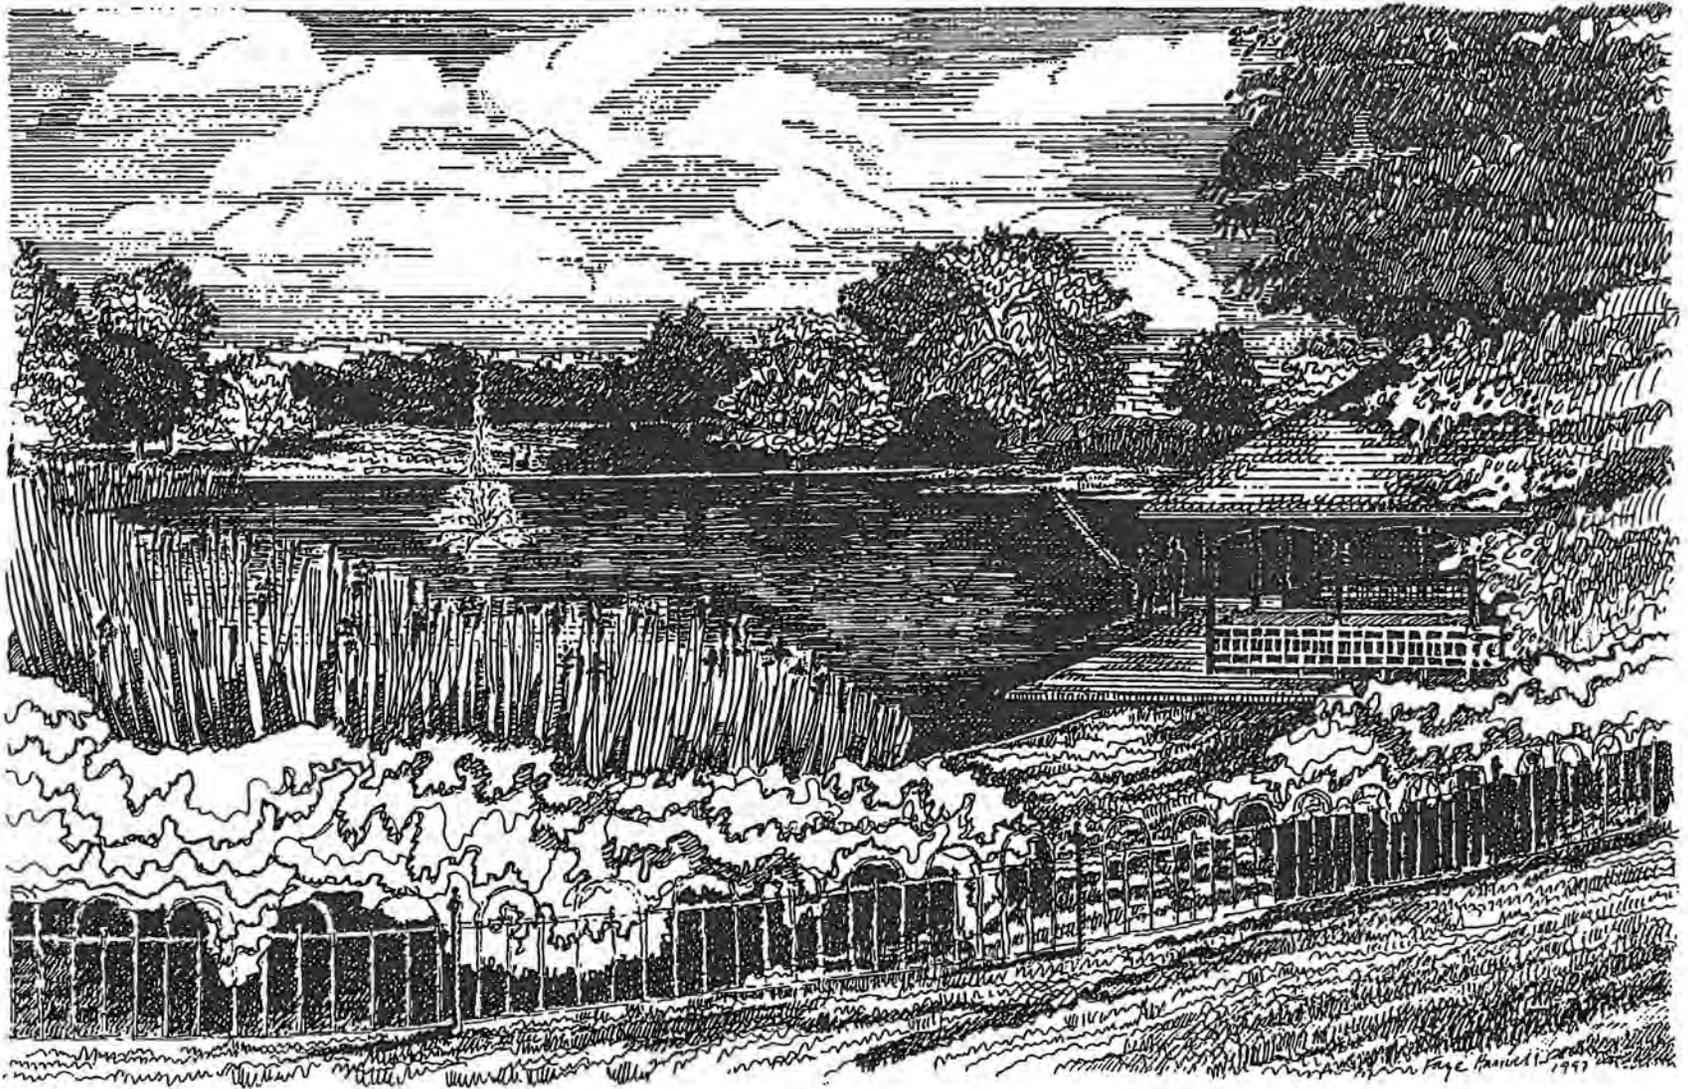
figure 32

VIEW OF RESTORED BOAT LAKE AND PAVILION, LOOKING SOUTHWEST

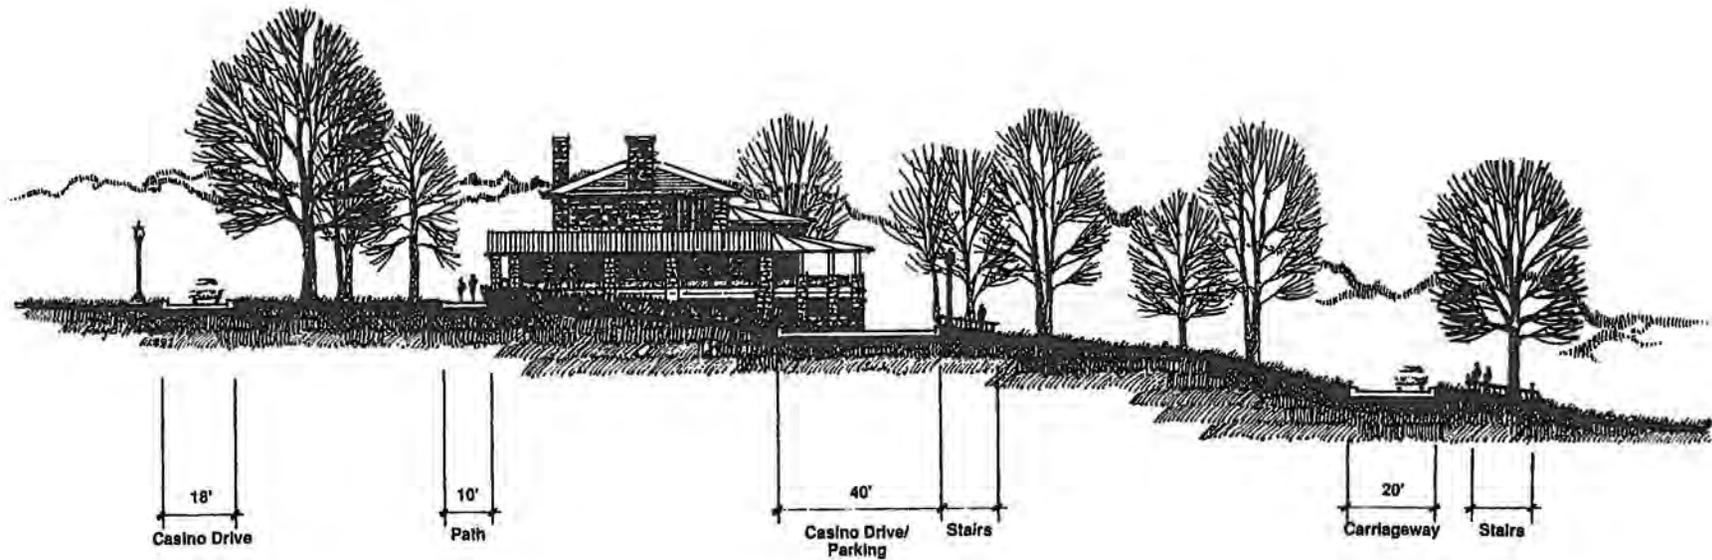
figure 34

SECTION THROUGH RENOVATED CASINO SITE, LOOKING NORTH

- Collaborate with the Commission on Aging during the renovation and restoration of the Casino building.
- Modify existing circulation in the vicinity of the Casino to eliminate vehicular use of the diagonal mall extension and move employee parking to the rear of the building. A new vehicular access road would begin at the existing carriageway northeast of the building. Pedestrian access should be up-graded to
